General Inspection (Snapshot) Report Six

Waterproofing systems for wet areas

September 2021

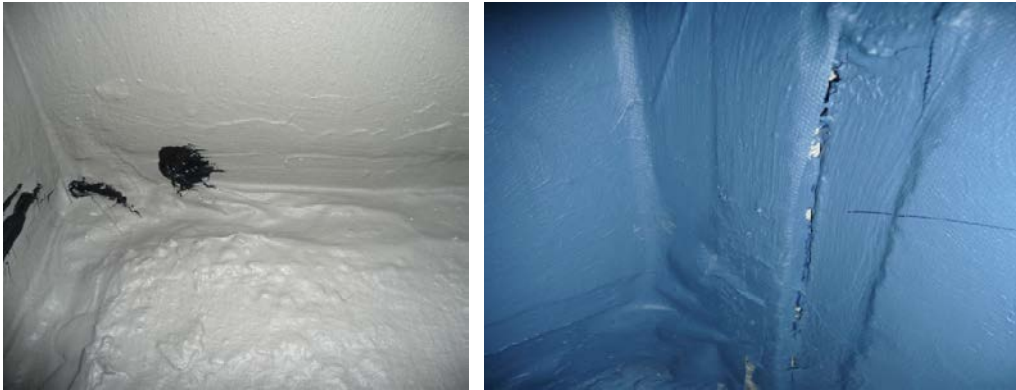
The substrates under waterproof membranes were not correctly prepared in accordance with the standards and manufacturers' installation instructions in 50 percent of the wet areas inspected for this item.

Figure 1 below shows some examples of substrates that had holes, unfilled cracks, sandy screeds, and rough surfaces.

Figure 1 Examples of poorly prepared substrates

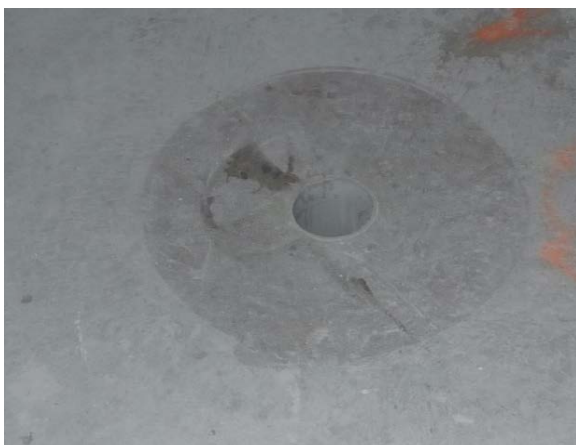
Building and Energy inspected seven wet areas where the drainage flanges in showers did not comply with the specifications in AS 3740-2010

Figure 2 below shows an example of a shower floor where a drainage flange was not installed.

Figure 2 Example of a missing drainage flange

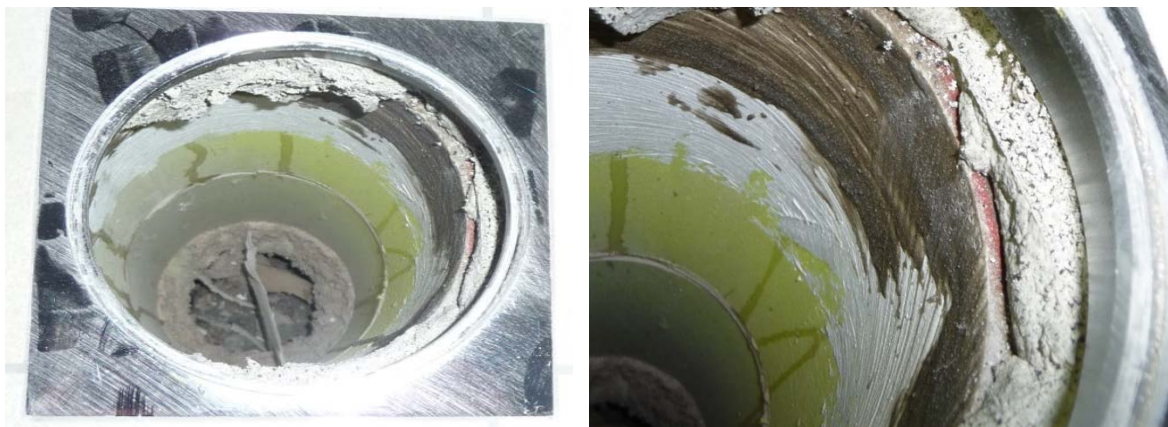
Figure 3 below shows an incorrectly installed waterproof membrane. The membrane was not carried across the top of the flange and the protrusion in the pipe could cause blockages.

Figure 3 Incorrectly installed membrane at drainage flange

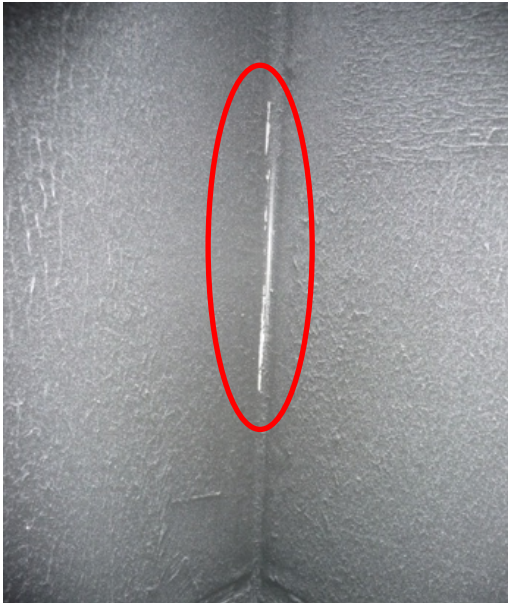
Building and Energy cut samples from several dried waterproof membranes. In all nine wet areas inspected for appropriate dry film thickness, the measured sample did not have the dry film thicknesses recommended by the manufacturers. In one case, the dry film thickness was only 0.25 mm.

Figure 4 below shows an example where the thickness of waterproof membrane in the corner of a shower was inadequate.

Figure 4 Example of a waterproof membrane in a shower that did not have the required thickness

Inadequate waterproof membrane thickness is a problem because thin membranes are more easily damaged. They are also less elastic and do not accommodate building movement as well as membranes that are the recommended thickness. Manufacturers' warranties may also be invalid if the membrane is not applied according to the manufacturers' recommendations. In one case, no waterproof membrane was installed in a shower.

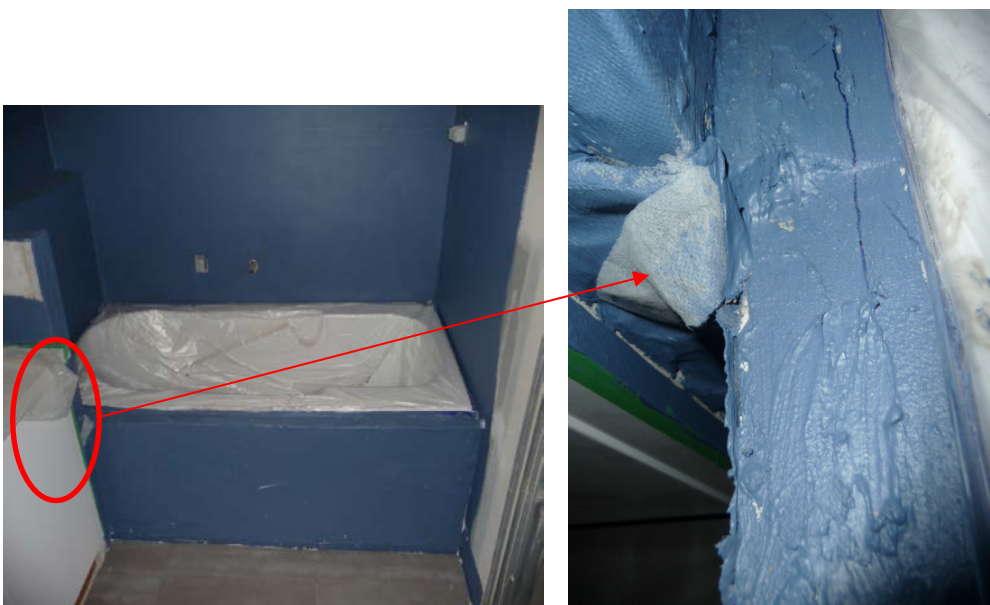
The areas surrounding the baths were rough and cracked, tape was exposed, and gaps were visible. The waterproof membrane was also not installed correctly between the bath and walls in all eight cases inspected.

AS 3740-2010 specifies that the waterproof membrane must extend under the lip of the bath. This was done satisfactorily in only one of the seven (14 percent) inspected wet areas with baths.

Figure 5 Example of poor workmanship around a bath
