APPENDIX 1

Apartment repairs and maintenance

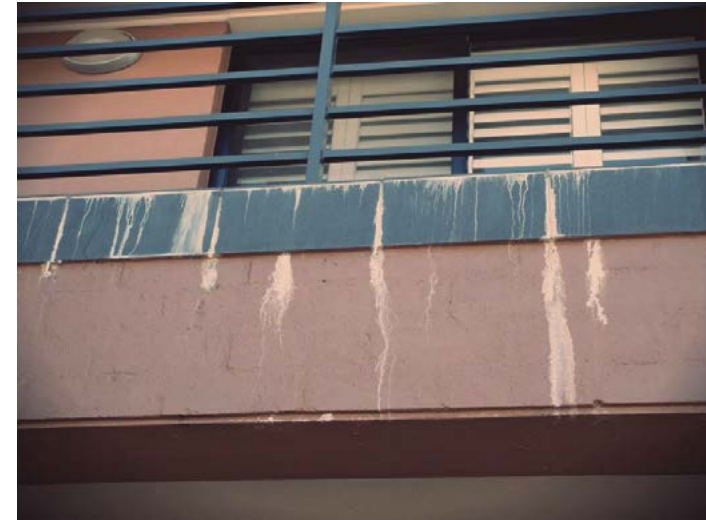
You also need to check the balcony's grout, because of UV it does have a high level of degradation. Look at the underside of your balcony, as well as the apartment below, as you can see tell tale signs of leaks i.e. white residue in a running pattern (refer below image). If you see this then it is best to contact an independent building inspector to investigate further.

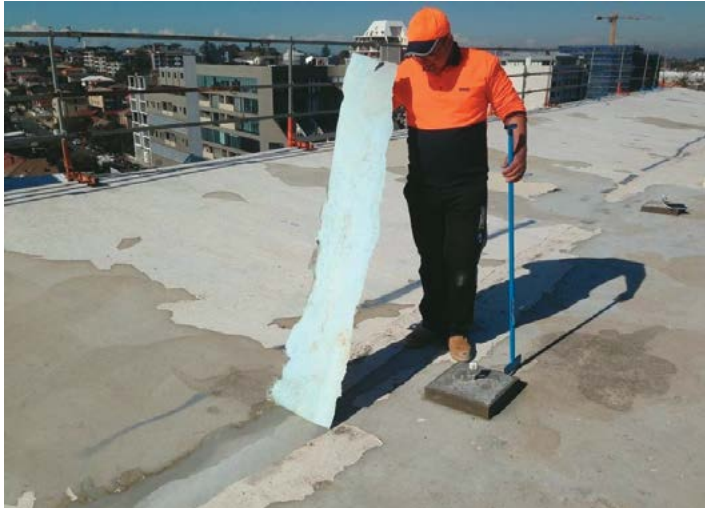
Applying waterproof membrane

Australian conditions are particularly harsh and very few membranes can last the 10+ warranted years without regular maintenance. A failing membrane will exhibit blistering, cracking or peeling away from the substrate. The most common areas of failure are around perimeters, drains and joints.

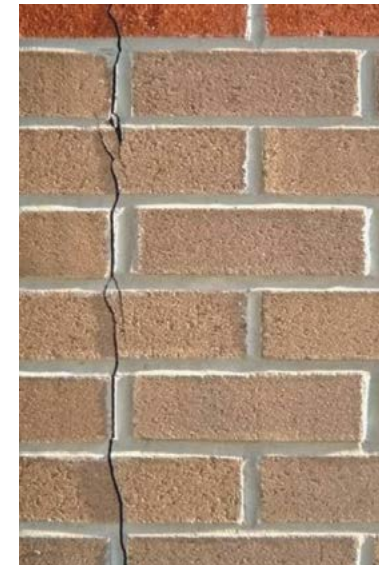
Thermal Cracking

Often any observed cracking to the brittle building elements is perceived as structural. The majority of the cracking to these elements will be due to a combination of differential settlement and or thermal movements. There are guides published in several Australian Standards that help to define the severity of the cracking observed. These include

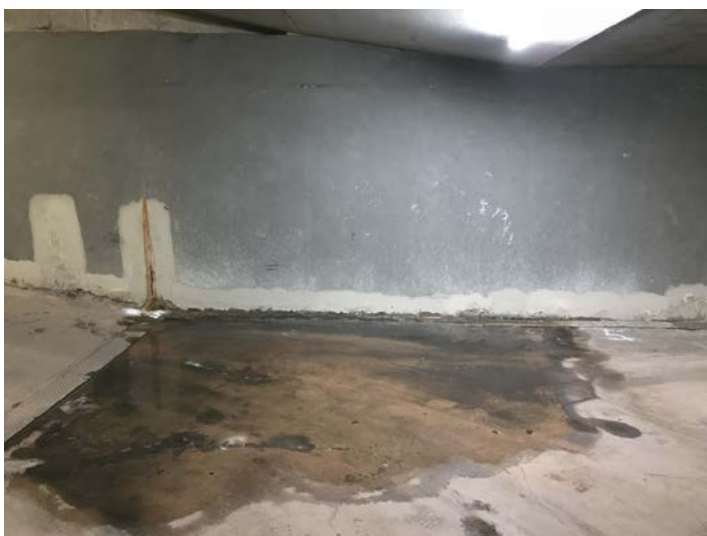
Water seeping through the basement wall

Water leaking through a crack in concrete or brickwork can be of significant concern. If you're worried about cracking in your building it may be worth checking with your Strata Company to see if a report on the cracking has been completed by a suitably qualified person.

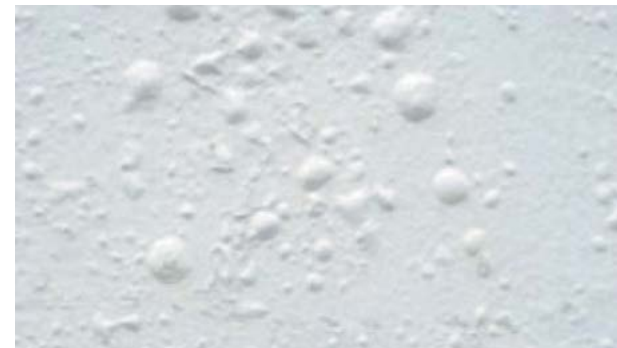
Blistering

Formation of bubble like shapes on the painted surface is known as blistering. The primary cause of this defect is water vapour. When water vapour is trapped under the paint layer, it creates bubbles under the film of paint. This could occur from rising damp, a leaking window or leaking pipe.

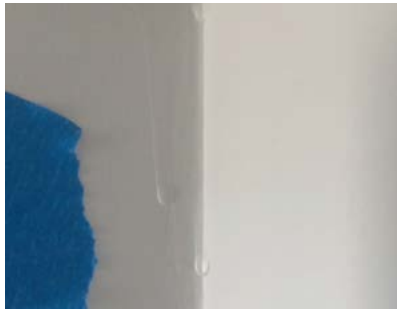
Paint Runs

This type of defect is more prominent when a thick layer of paint is applied on a vertical or inclined surface without it being laid off fully.

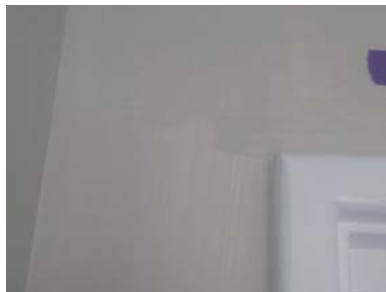
Lack of Opacity (Coverage)

This type of defect occurs when additional coats of paint have not been applied.

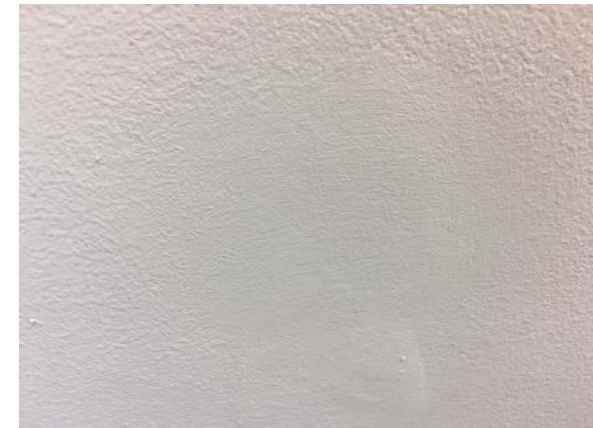
Irregular texture

This defect can occur when patching is done over an already painted wall that has a texture from a roller.

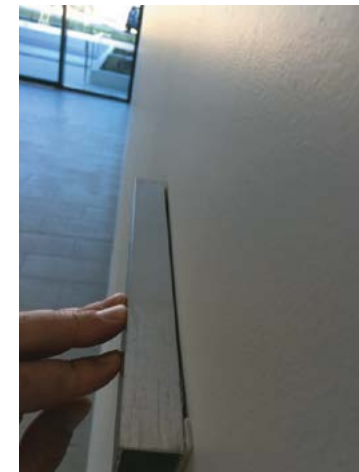
Gypsum Lining Boards

A tolerance of up to 2mm is allowed at gypsum lining board joints when assessed in accordance with AS/NZS2589 Gypsum Linnings – Application and Finishing Section 4.7.2. Joints may be noticeable in critical light but should not be noticeable in normal light when viewed front on at 1.5 – 2m.

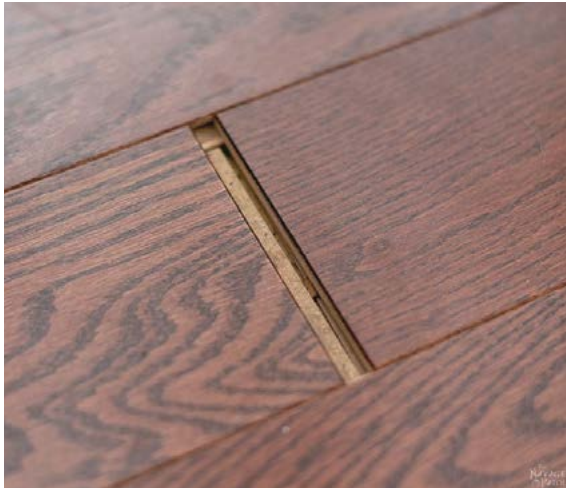
Cracks and Separations between Boards

With changes in the climate, boards can shrink, and spaces appear between the boards as the wood loses moisture content (MC). Some of these variations are seasonal problems and will close up on their own when the weather changes and the MC of the air increases. Monitoring the room's temperature, then taking corrective action, can also minimize seasonal shifts in the wood floor.
