General Inspection (Snapshot) Report Six

Waterproofing systems for wet areas

September 2021

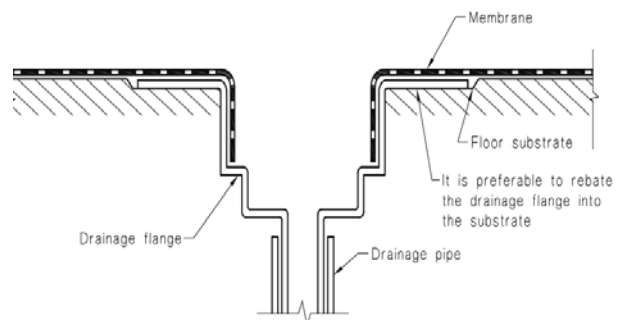
Figure 3 Incorrectly installed membrane at drainage flange

Figure 3 below shows an incorrectly installed waterproof membrane. The membrane was not carried across the top of the flange and the protrusion in the pipe could cause blockages.
